Wai Nui Farms Reuse and Best Practice Surface Irrigation system

AGRICULTURE VICTORIA

Macalister Irrigation District Irrigation Incentives Program

Project: Best Practice Surface Irrigation (BPSI) and Reuse System

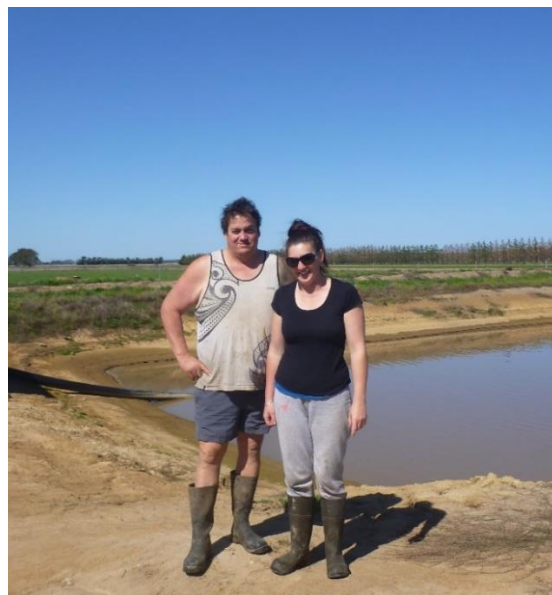
Zane and Bernie in front of their new reuse system.

It began with a reuse system being constructed to catch all runoff from 105 ha in a large 10ML dam. The reuse system can be currently reused over 16 hectares, but once the next stage is completed (estimated Oct 2018) then the reuse system will be able to be used over 50 hectares. This ensures that tail water and nutrients are reused on farm instead of being lost down the drain. It will also allow for flexibility in irrigation timing and provides an opportunity to irrigate over winter.

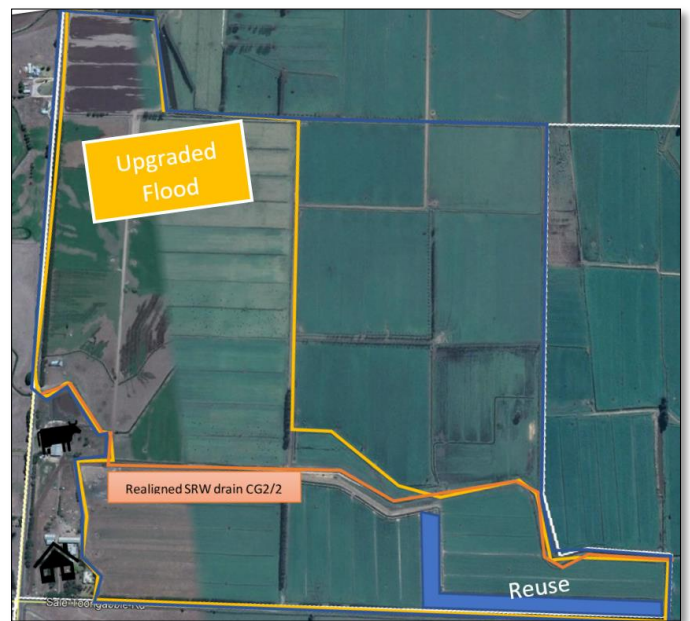
Map of the area that has been upgraded.

The upgrade has significantly changed the irrigation and drainage that occurs on the farm. The opportunity to reset the irrigation layout has provided many options for Wai Nui Farms. Due to the rationalisation of the farm outlets, they were able to convert an old SRW spur channel into a farm channel and they were able to take over some of the SRW drain that cut the area. They were also able to realign the major SRW drain to straighten it up. Redesigning the irrigation bays completely allowed for the inclusion of the hard to irrigate areas – increasing the area irrigated by 21 hectares.

The area is now supplied by a 20ML/day farm channel, which can supply 14ML/day flow rates on to the bays. All bays have been set up with good slopes and drainage that runs to the reuse system. The bay outlets installed can be automated.

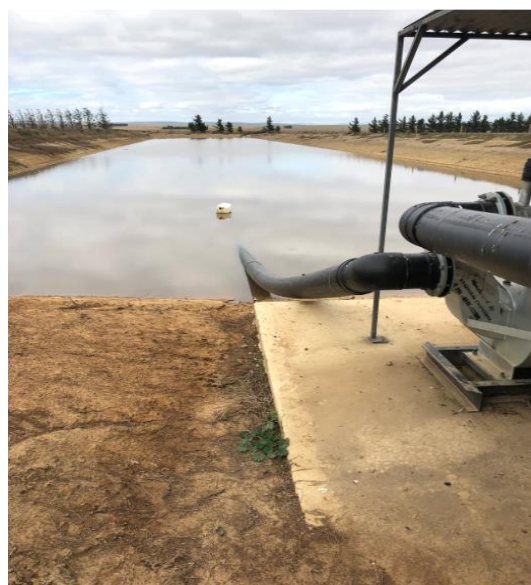
The 10ML reuse system.

After installing the reuse system, all nutrients applied to the 105 ha is being retained on-farm.
